Assessment of Dam Safety of Coal Combustion Surface Impoundments

Indianapolis Power & Light Company

Harding Street Generating Station

November 15, 2010

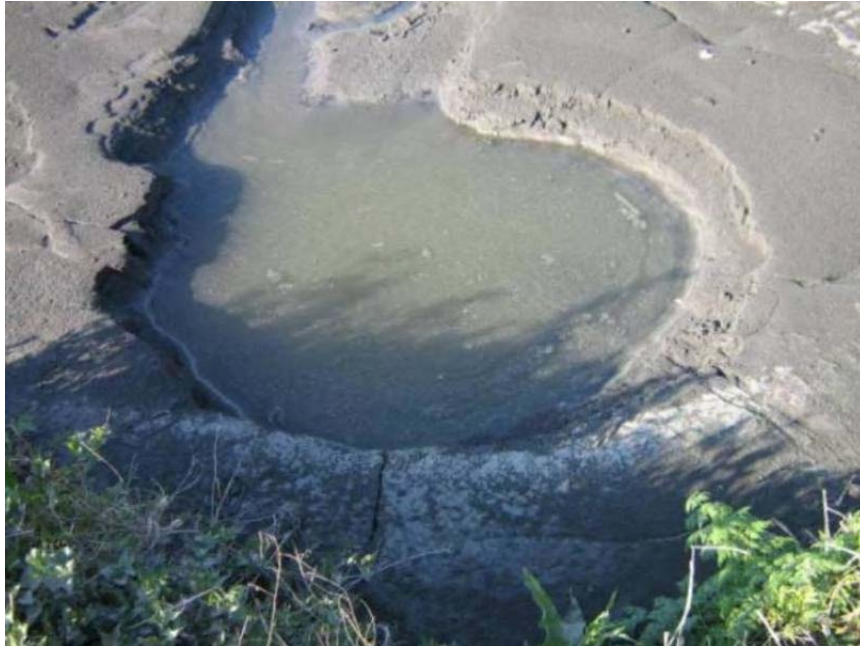
107. Ash Pond 4 - Submerged Inlet from Ash Pond 4A

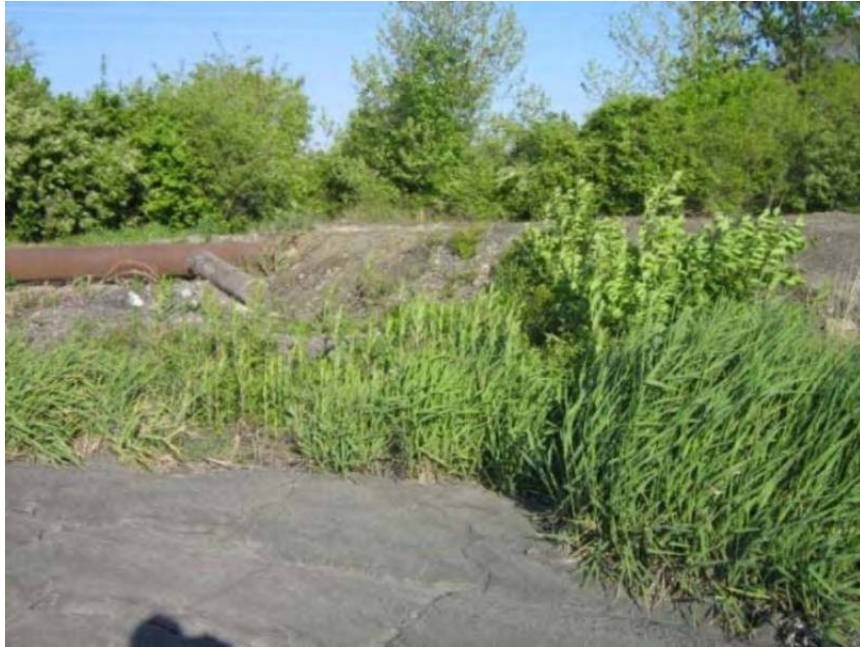
109. Ash Pond 4 - Erosion along the Northwestern Embankment
Interior Slope

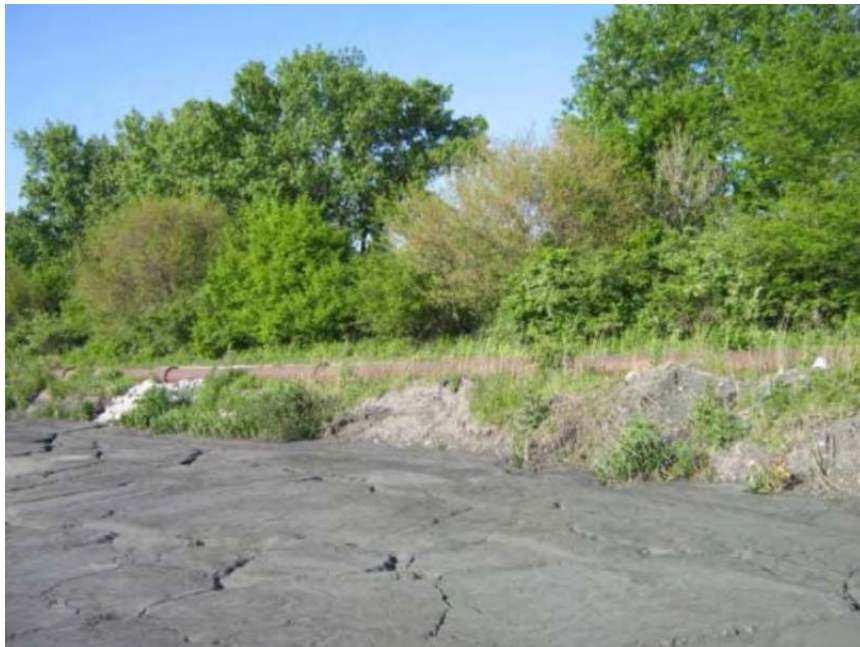
110. Ash Pond 4 - West Embankment Interior Slope, View from
Pond

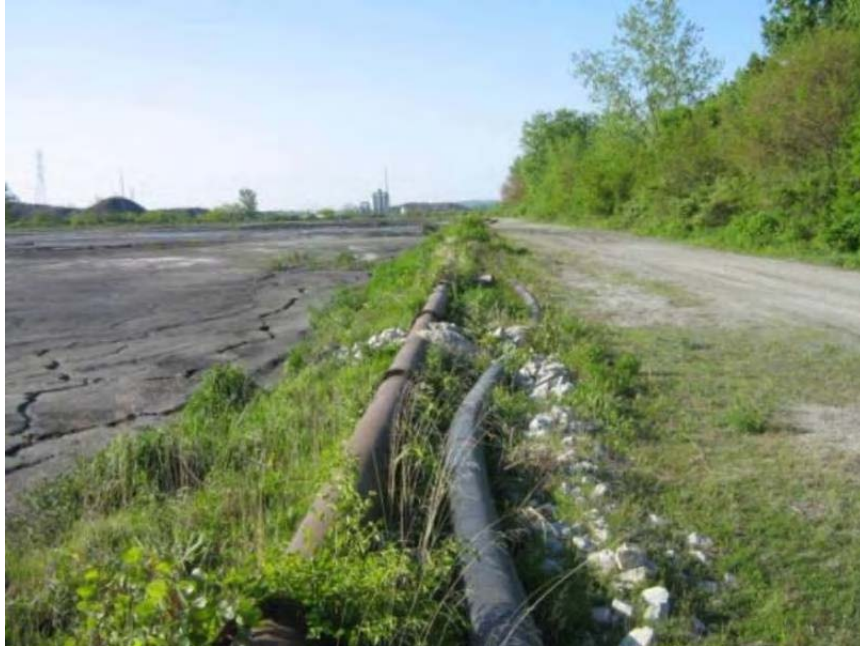
111. Ash Pond 4 - Sluice Lines Located along West Embankment
Interior Slope, Looking South

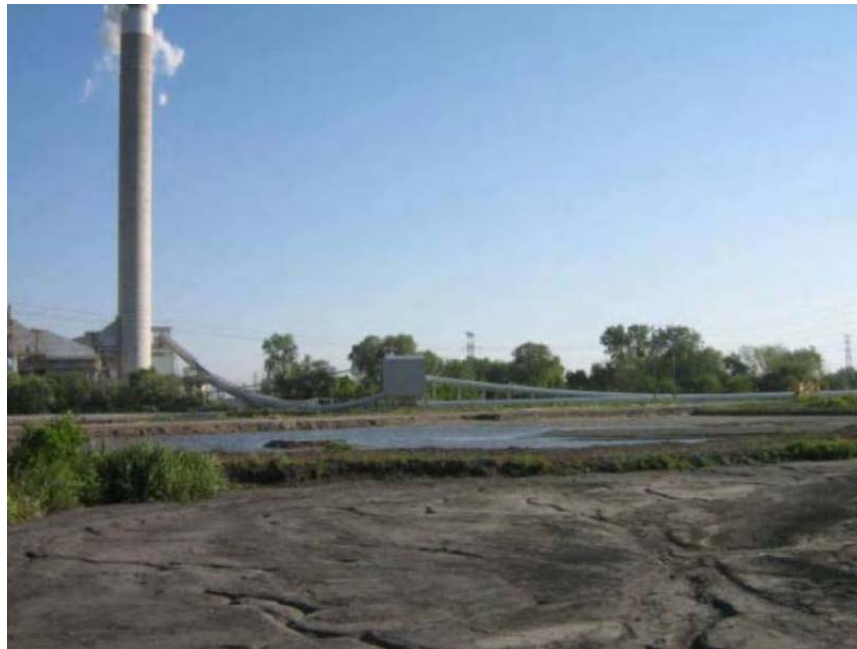
113. Ash Pond 4 - Freeboard along North Embankment Interior Slope

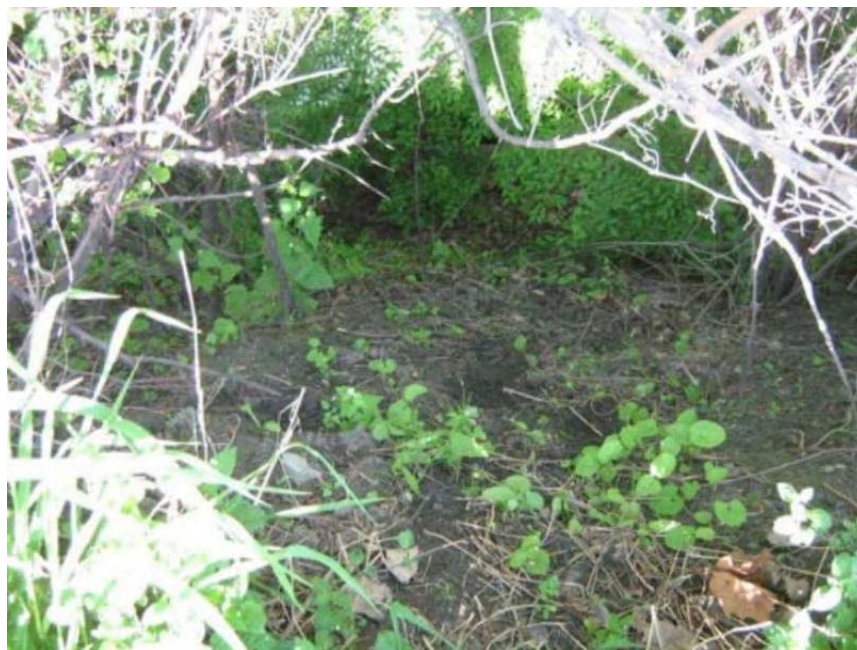
114. Ash Pond 4 - West Embankment Interior Slope, Looking West

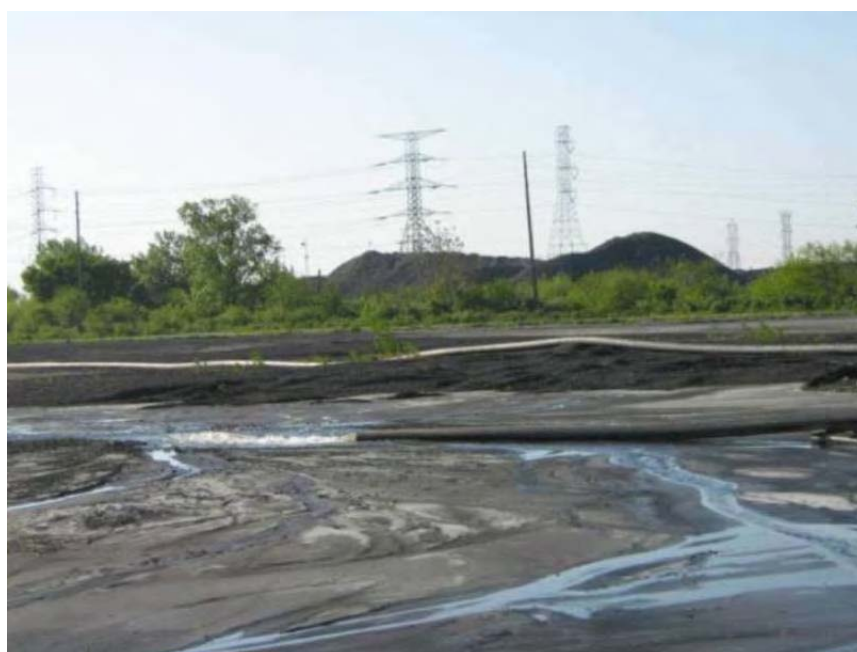
116. Ash Pond 4 - Discharge into Pond along West Embankment
Crest

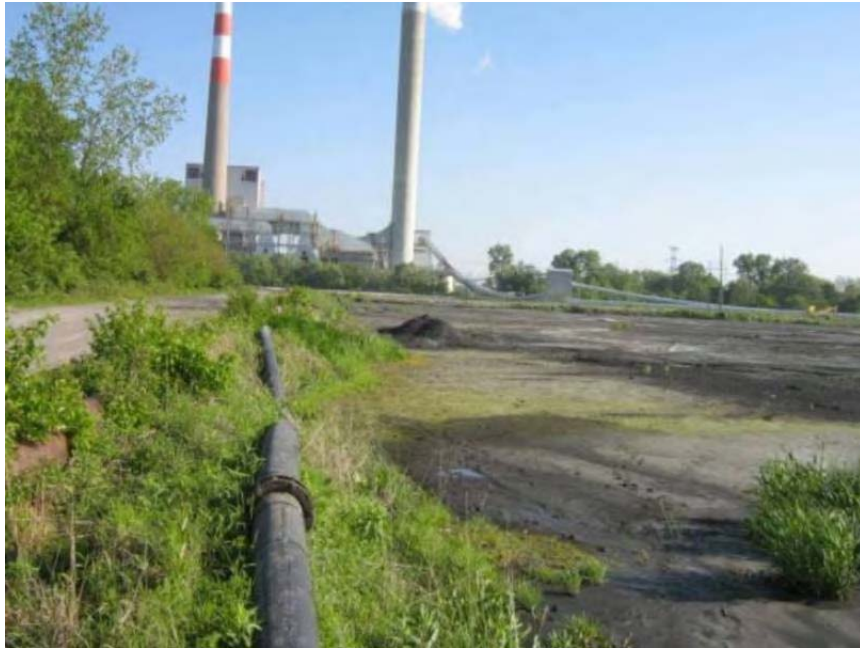
117. Ash Pond 4 - West Embankment Interior Slope and Pipeline,
Looking North

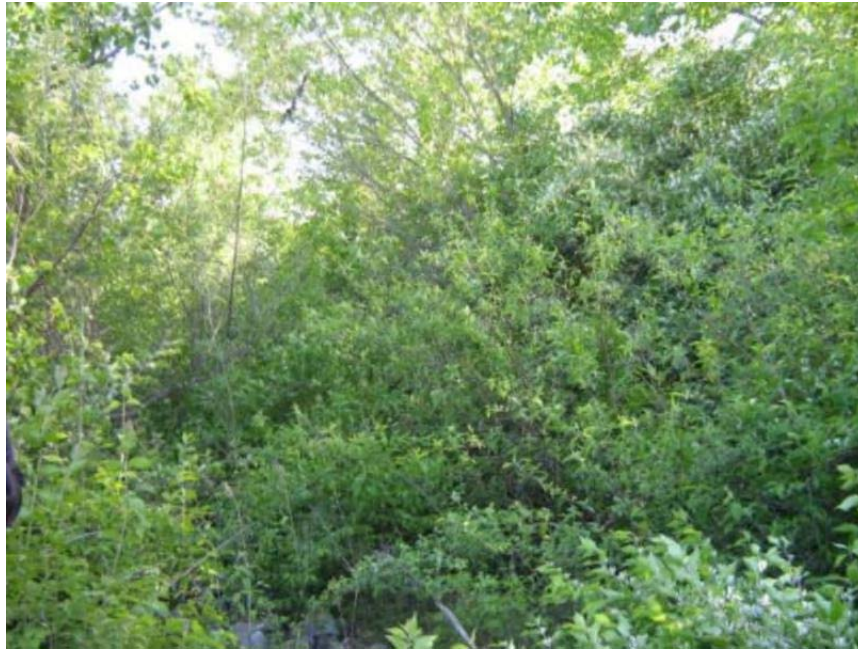
121. Ash Pond 4 - West Embankment Exterior Slope, Heavy Vegetation on Slope

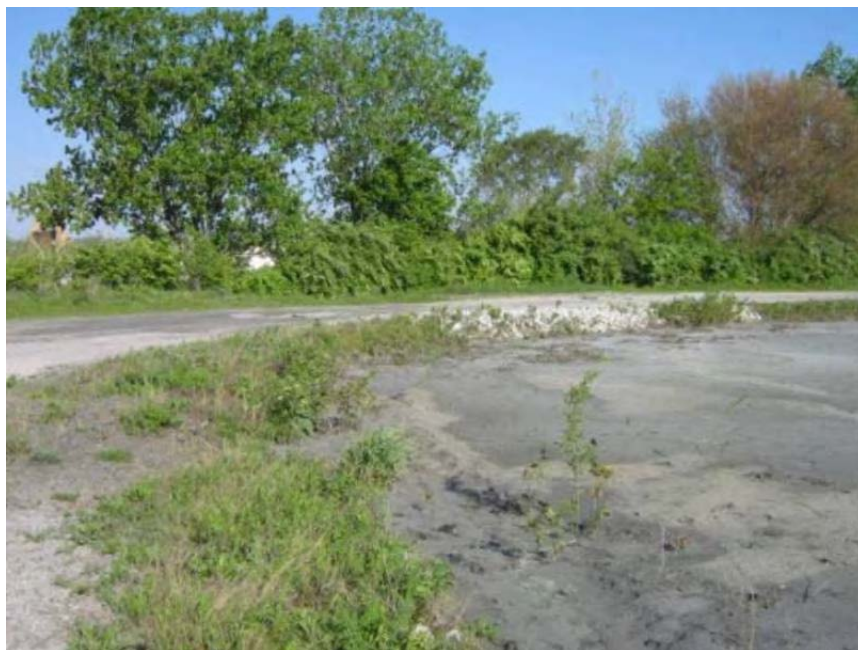
122. Ash Pond 4 - West Embankment Interior Slope, Looking West

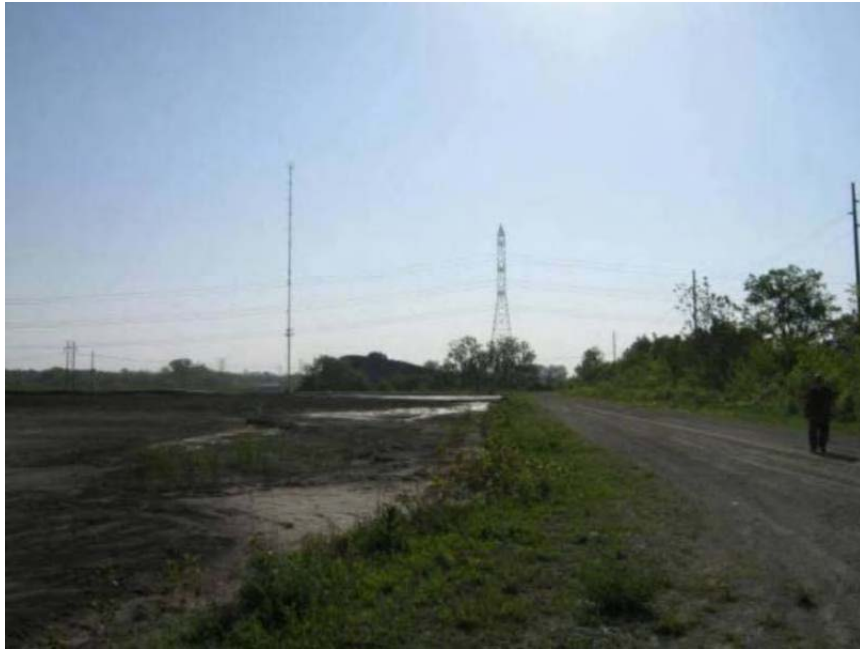
123. Ash Pond 4 - South Embankment Crest and Interior Slope,
Looking East

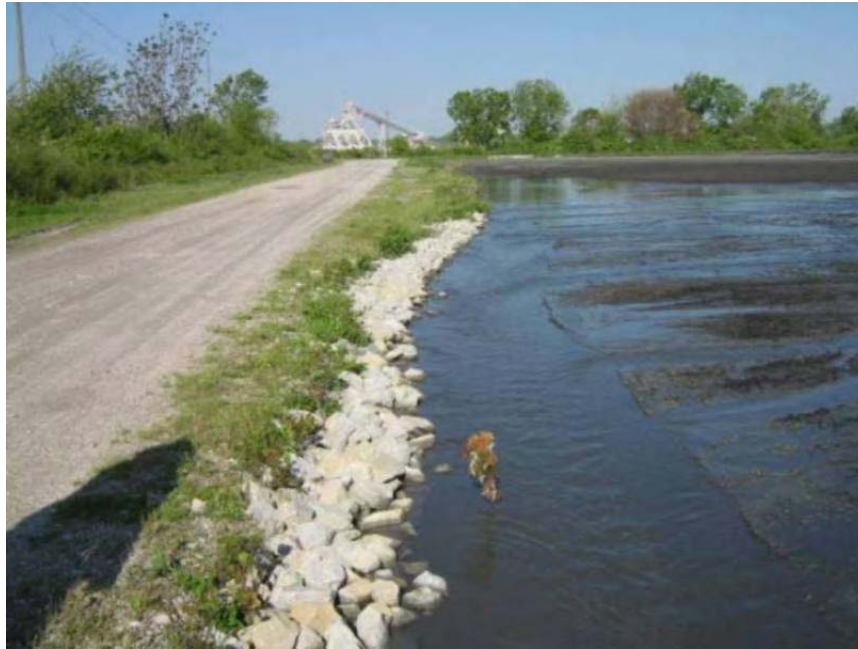
125. Ash Pond 4 - South Embankment Interior Slope, Looking West,
Riprap Placed to Waterline

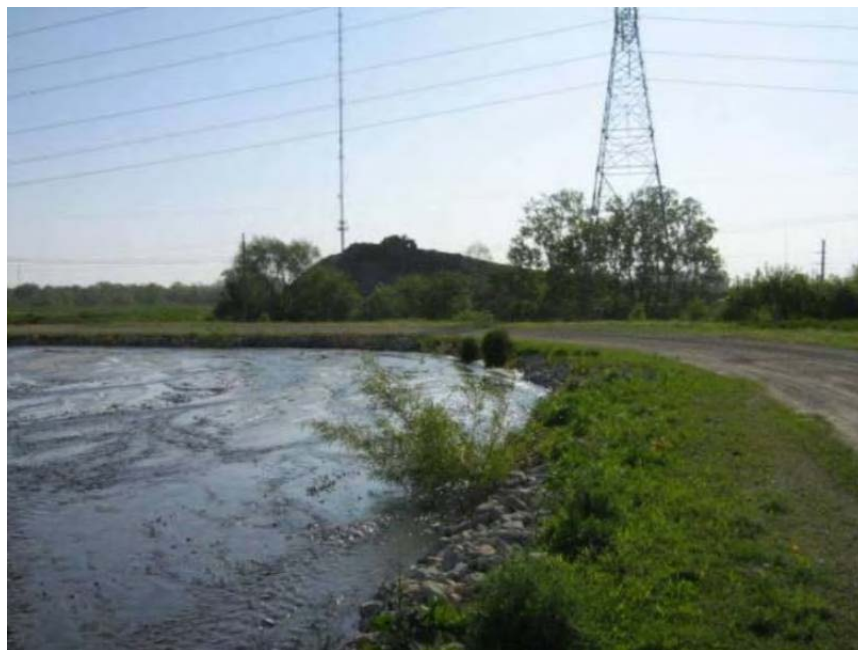
126. Ash Pond 4 - Southeastern Embankment Interior Slope,
Looking East

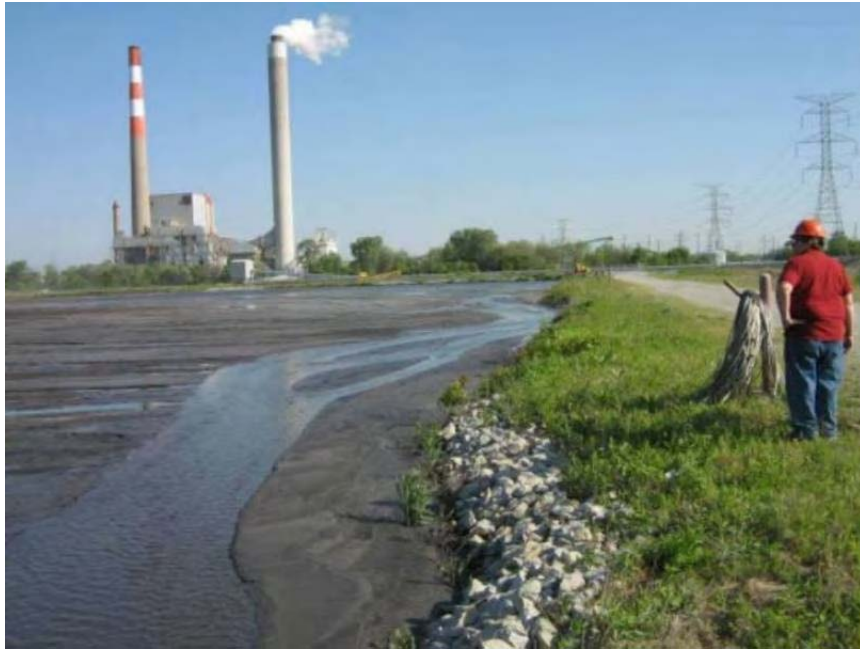
127. Ash Pond 4 - East Embankment Interior Slope, Looking North

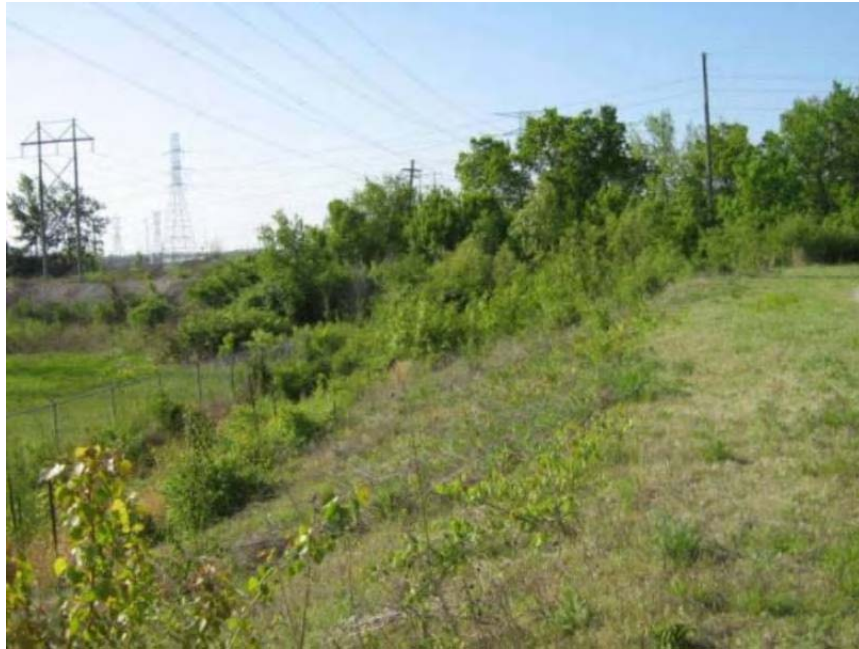
129. Ash Pond 4 - East Embankment Exterior Slope, Looking South

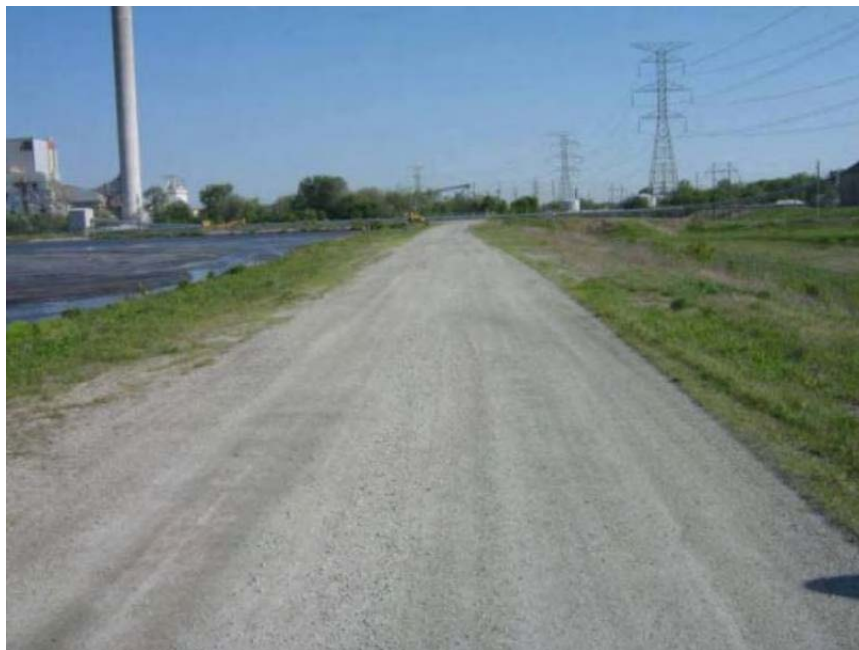
130. Ash Pond 4 - East Embankment Crest, Looking North

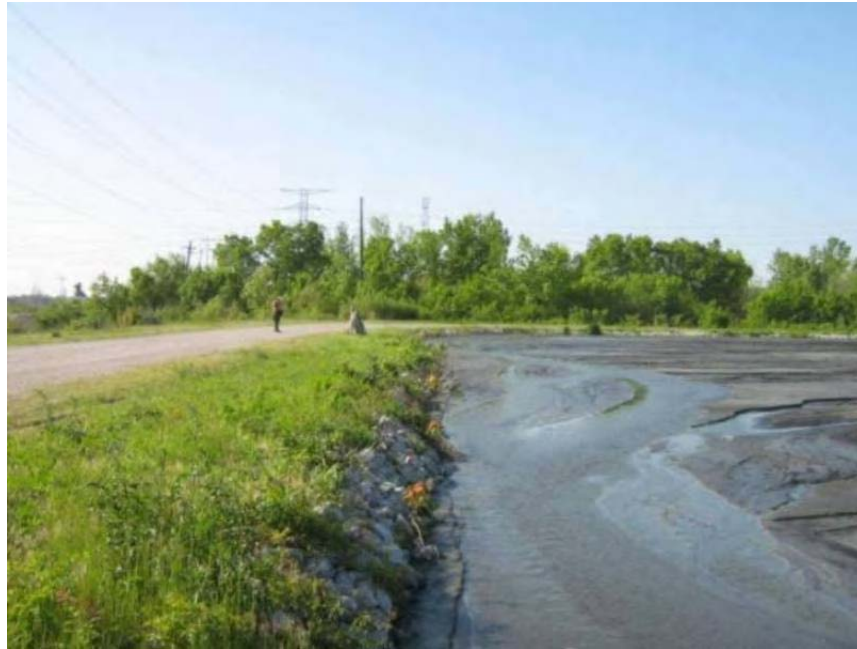
131. Ash Pond 4 - East Embankment Interior Slope, Looking South

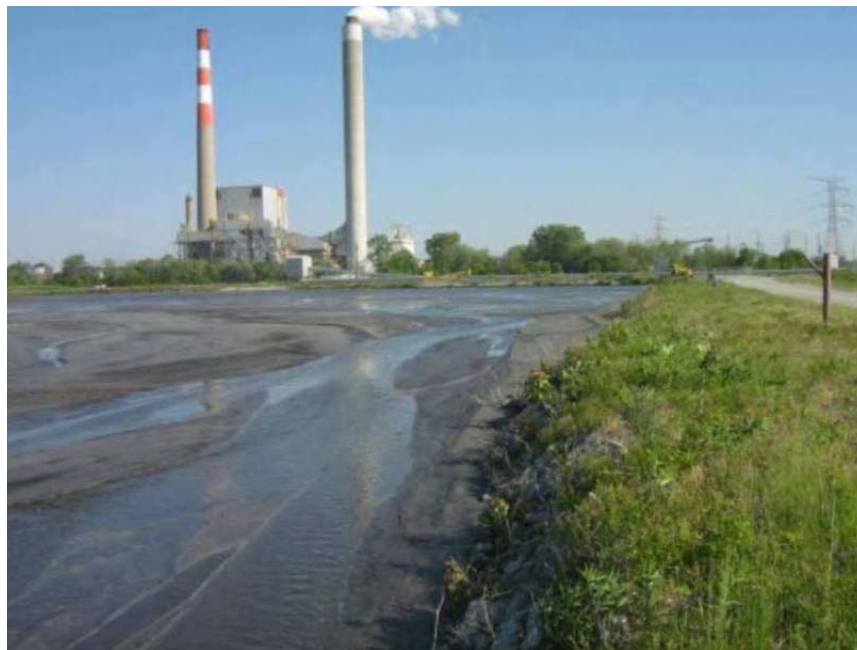
132. Ash Pond 4 - East Embankment Interior Slope, Looking North

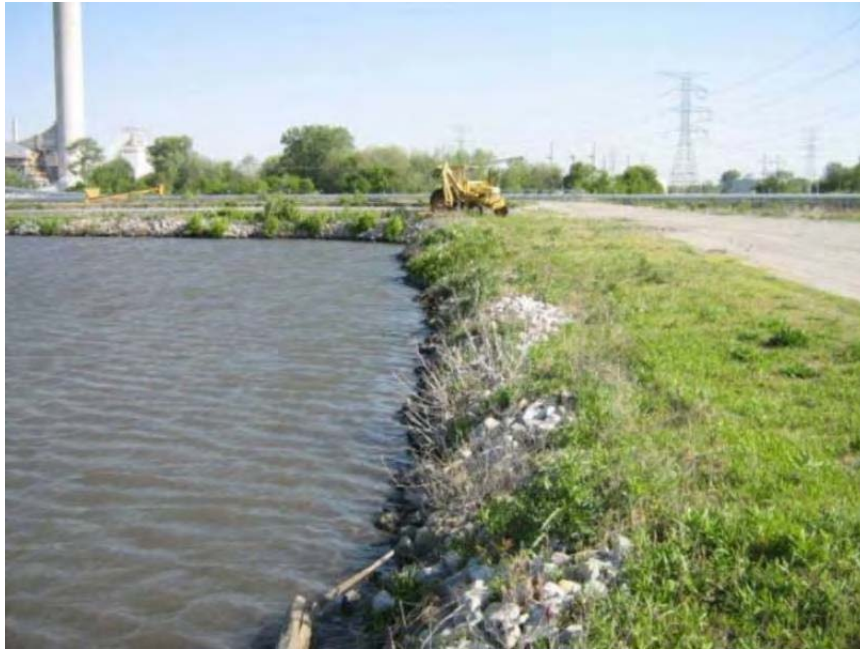
133. Ash Pond 4 - East Embankment Interior Slope, Looking North,
Riprap lines the Interior Embankment

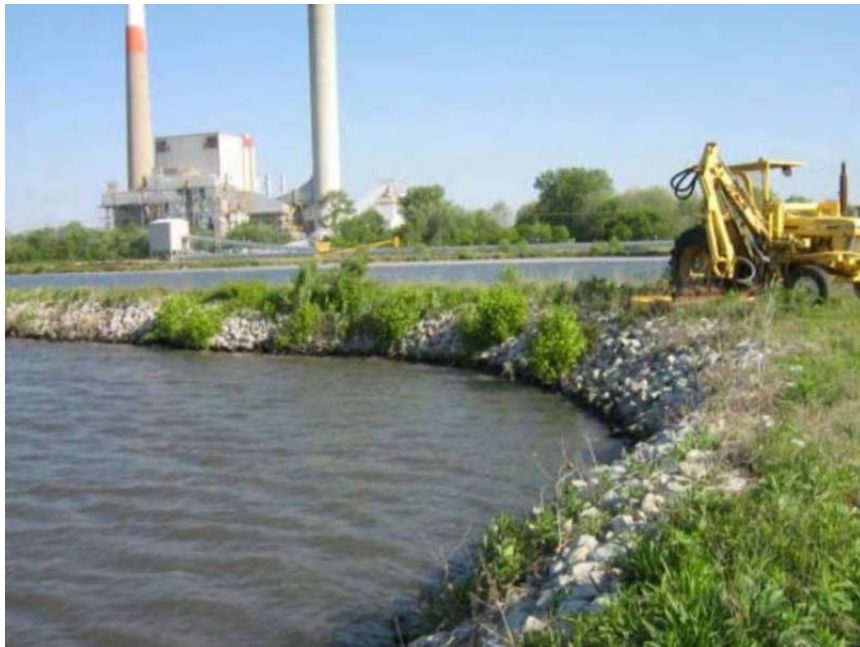
134. Ash Pond 4 - Northeastern Embankment Interior Slope,
Looking North, Riprap lines the Interior Embankment

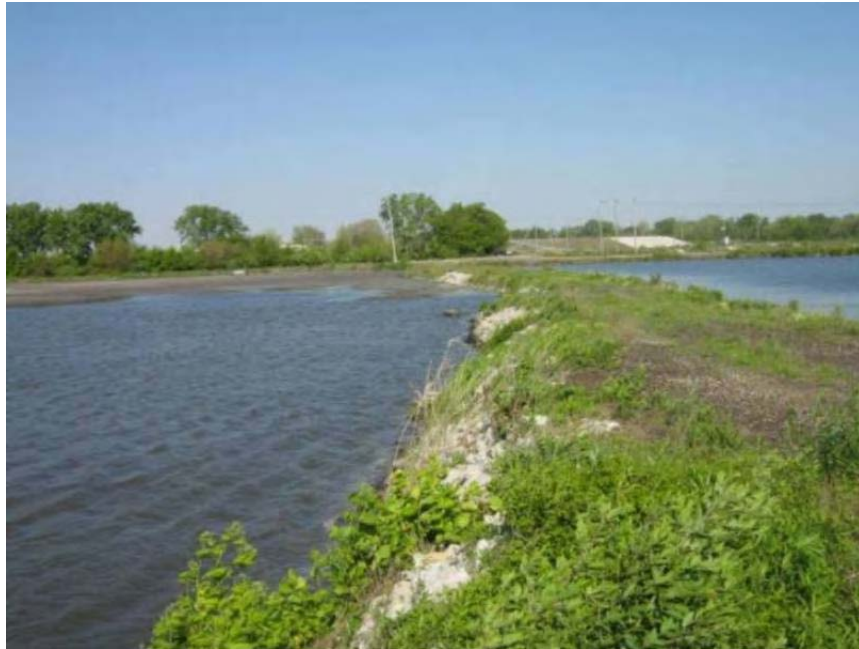
135. Ash Pond 4 - North Embankment Interior Slope, Looking West,
Vegetation is Present

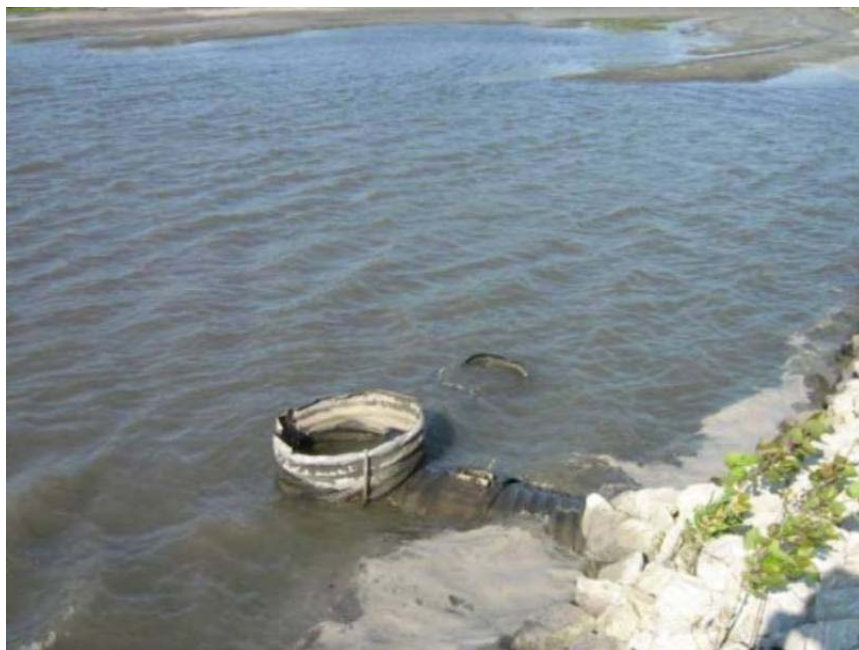
136. Ash Pond 4 - Two (2) 30-inch-Diameter CMP Outlets to Ash
Pond 4B

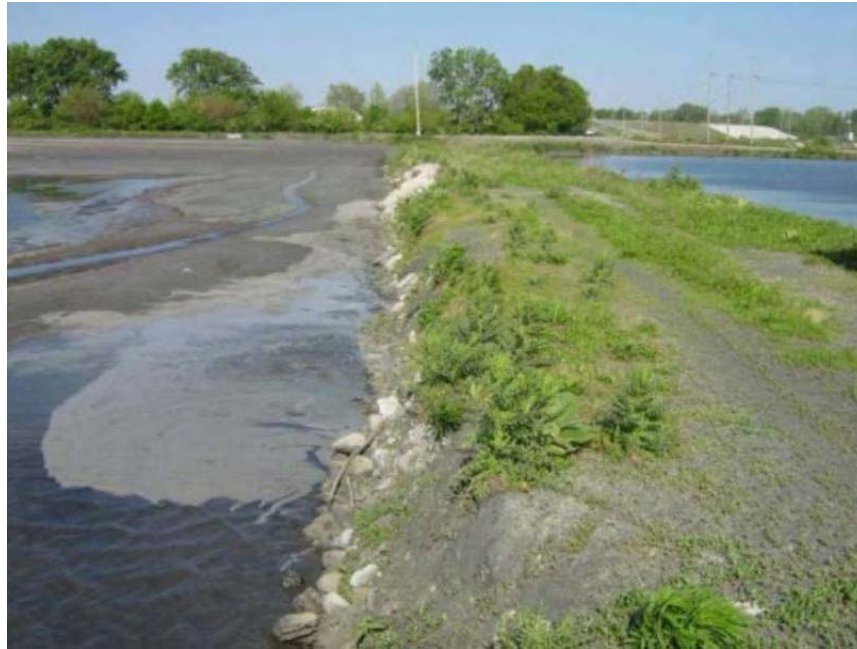
137. Ash Pond 4 - Erosion of Riprap along the North Embankment
Interior Slope, Looking West

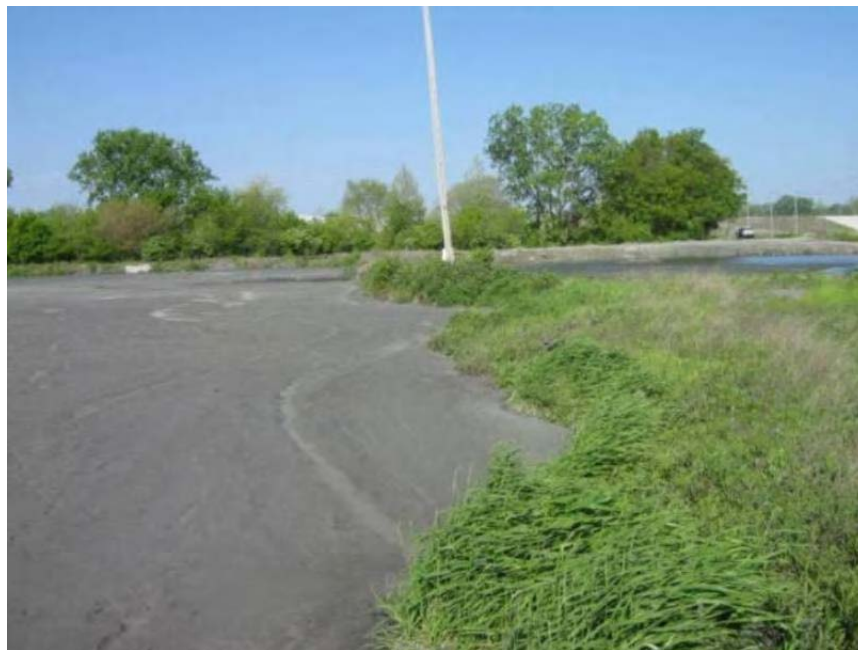
138. Ash Pond 4 - North Embankment Interior Slope, Looking West

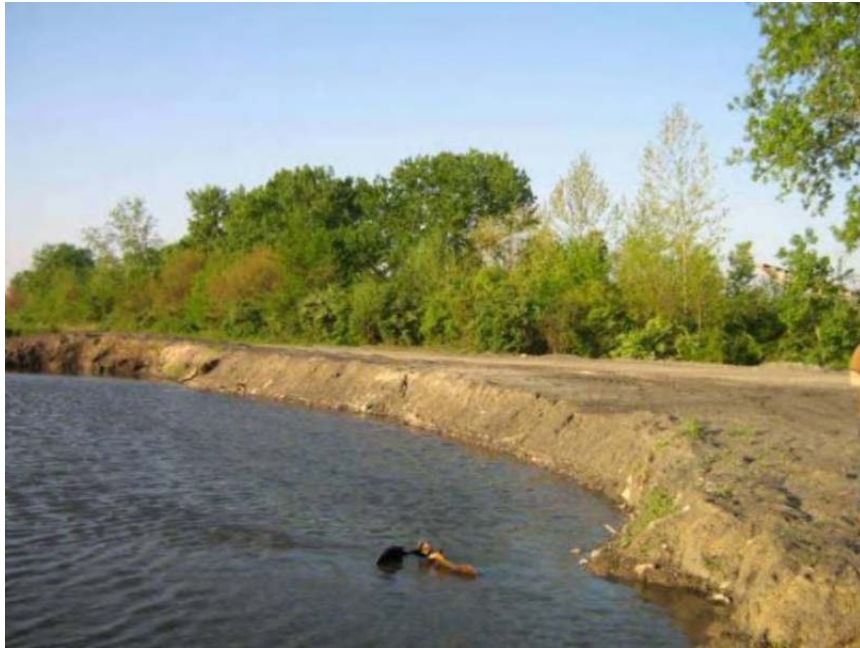
139. Ash Pond 4A - North Embankment Interior Slope, Looking West

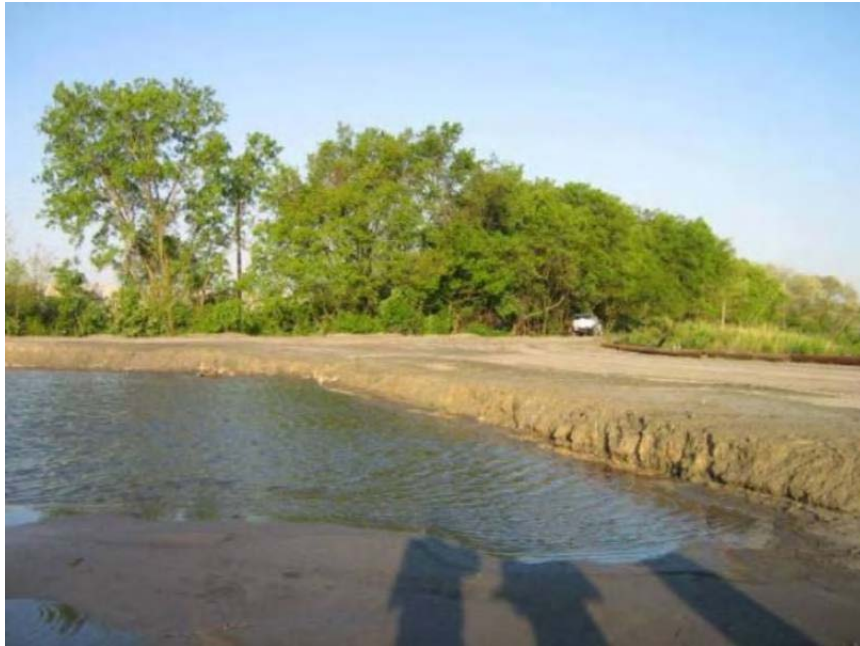
141. Ash Pond 4A - North Embankment Interior Slope, Looking Southwest from Pond

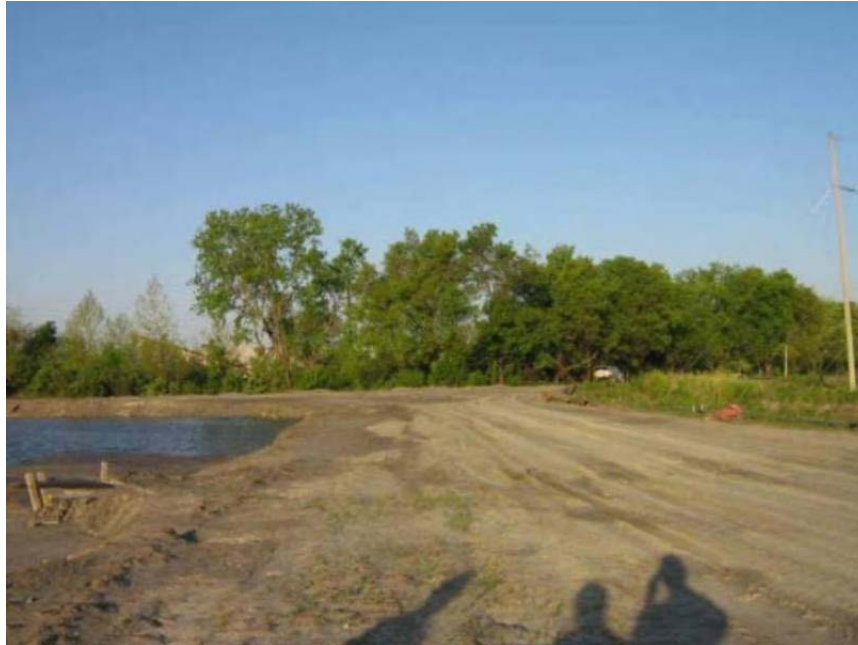
143. Ash Pond 4A - North Embankment Crest, Looking West

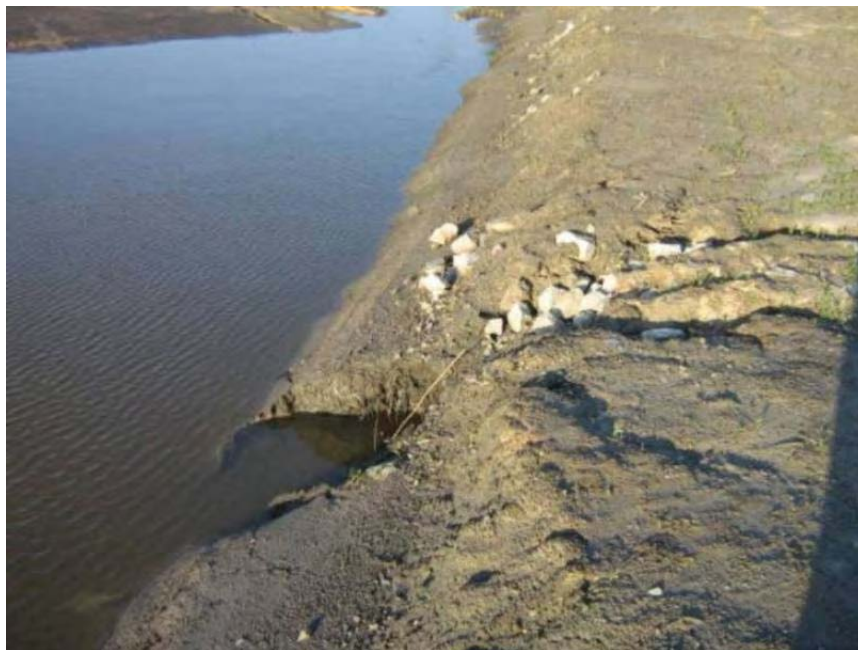
144. Ash Pond 4A - Erosion Rill on North Embankment Interior Slope

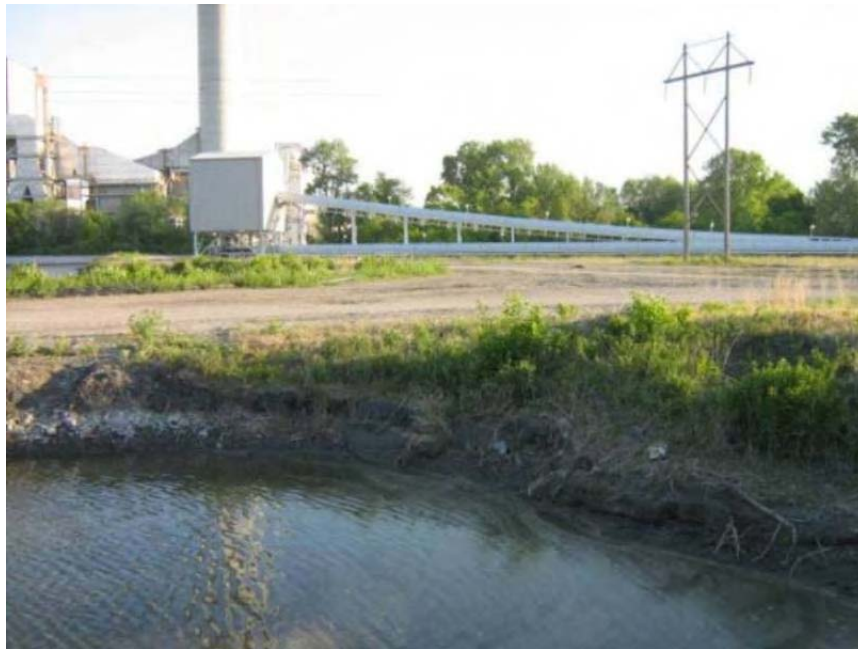
145. Ash Pond 4A - Beaching at Base of East Embankment Interior Slope, Looking North

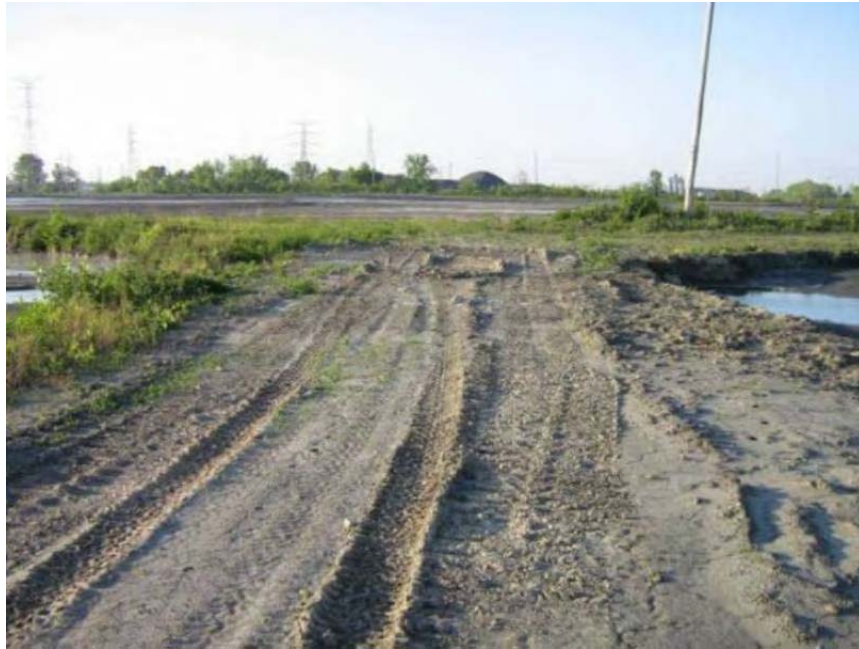
147. Ash Pond 4A - East Embankment Crest, Looking South

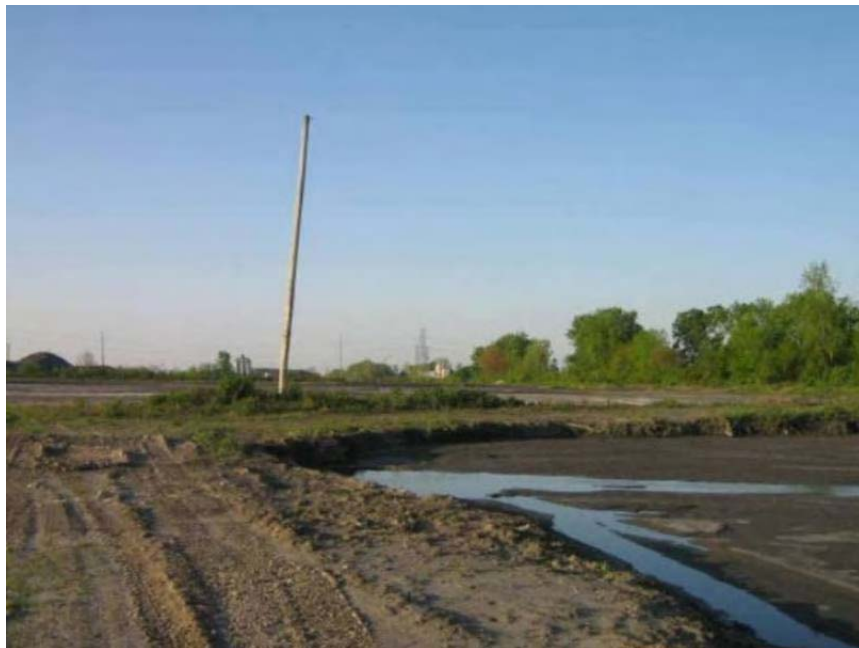
148. Ash Pond 4A - South Embankment Interior Slope, Looking South

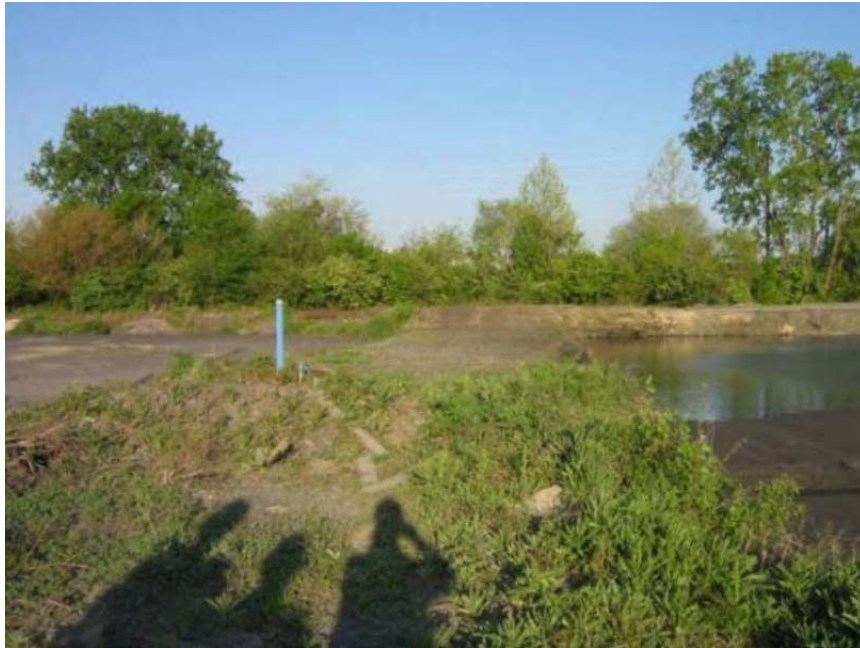
151. Ash Pond 4A - South Embankment Crest, Looking West

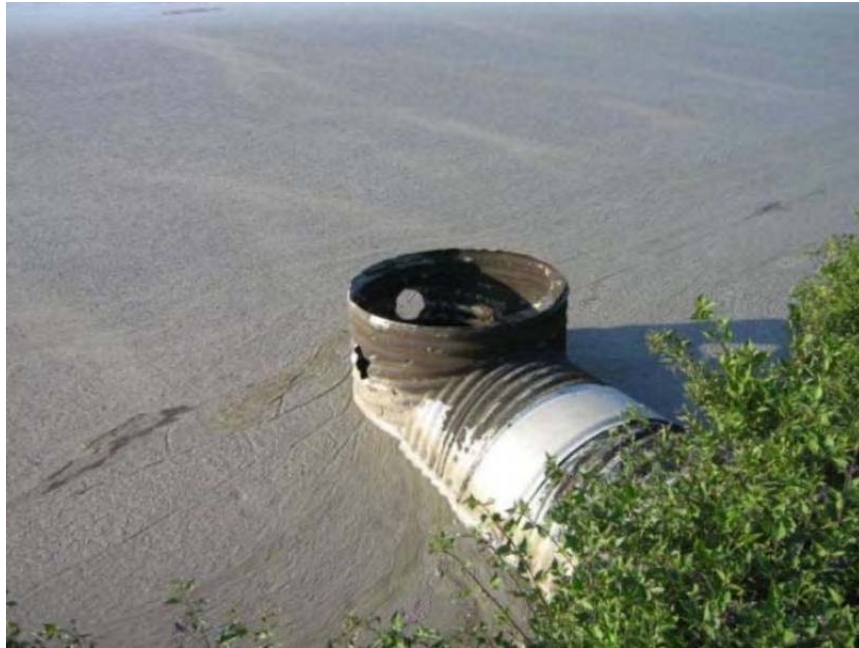
154. Ash Pond 4B - Outlet to Ash Pond 3 Located at Northeastern Corner of Pond

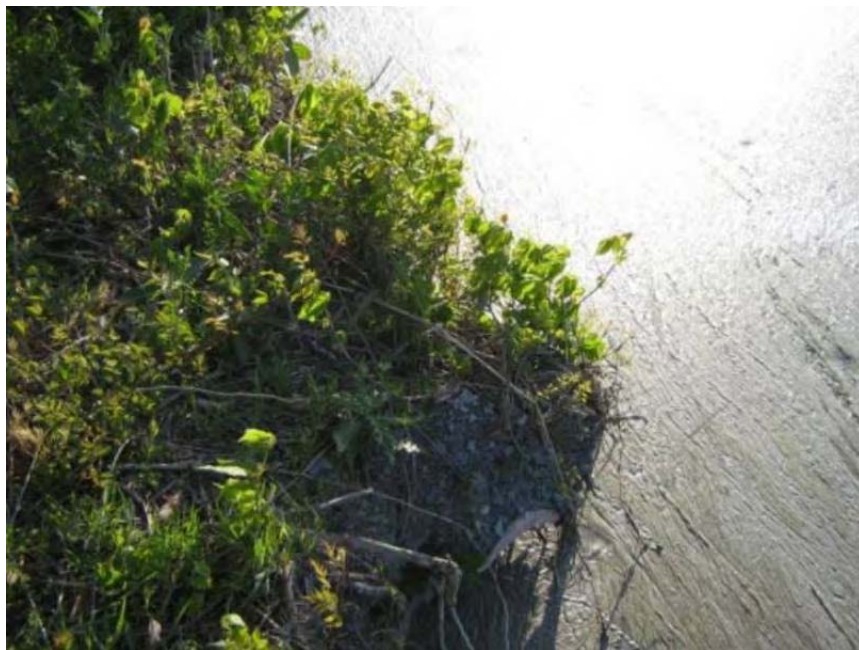
155. Ash Pond 4B - Undercut North Embankment Interior Slope, Looking East

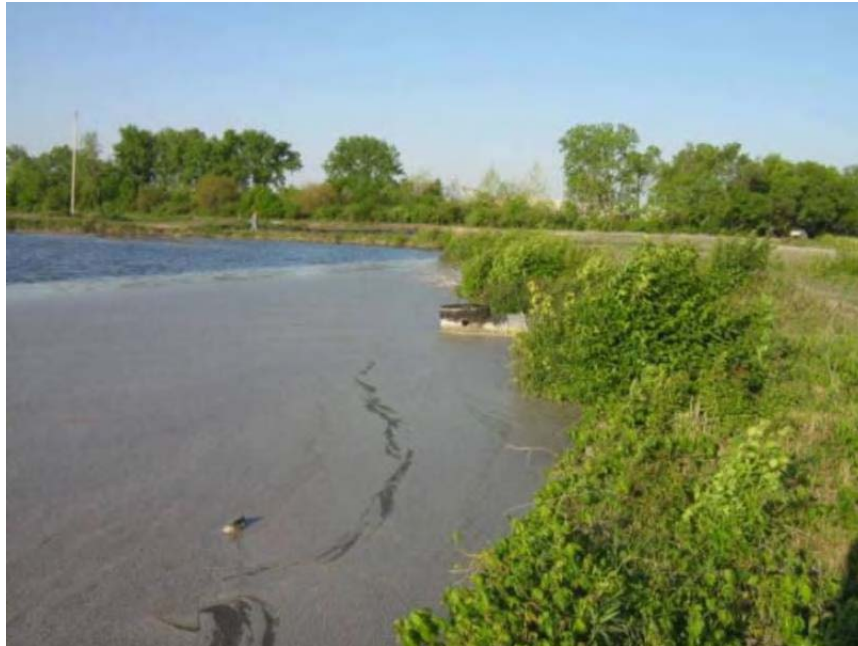
156. Ash Pond 4B - North Embankment Interior Slope, Looking West

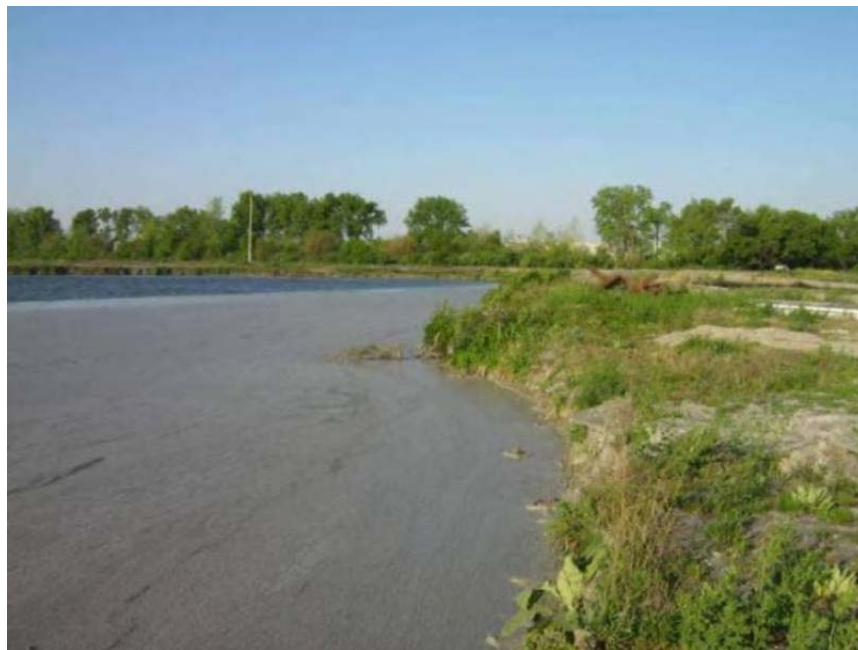
157. Ash Pond 4B - North Embankment Interior Slope, Looking West

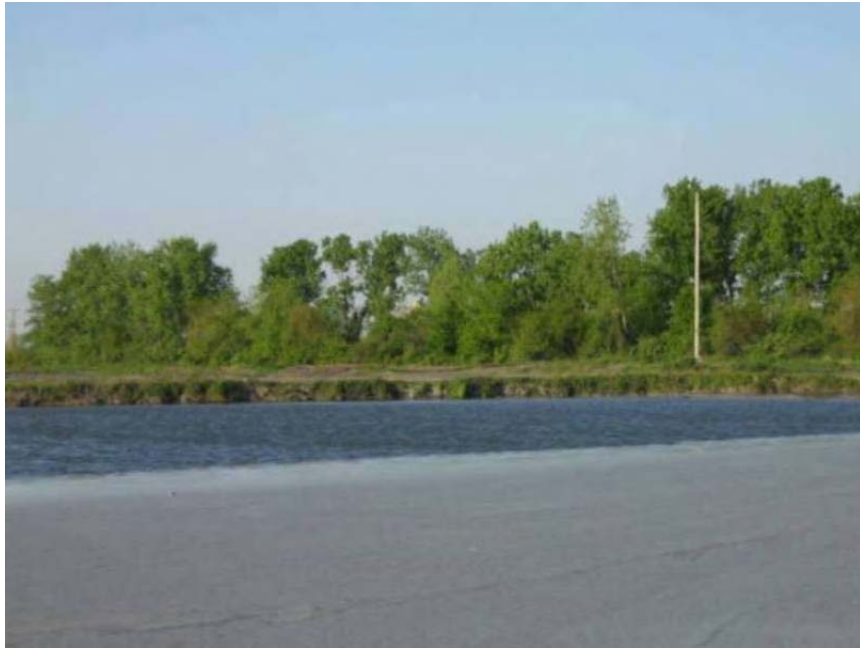
158. Ash Pond 4B - West Embankment Interior Slope, Looking West, Erosion Visible

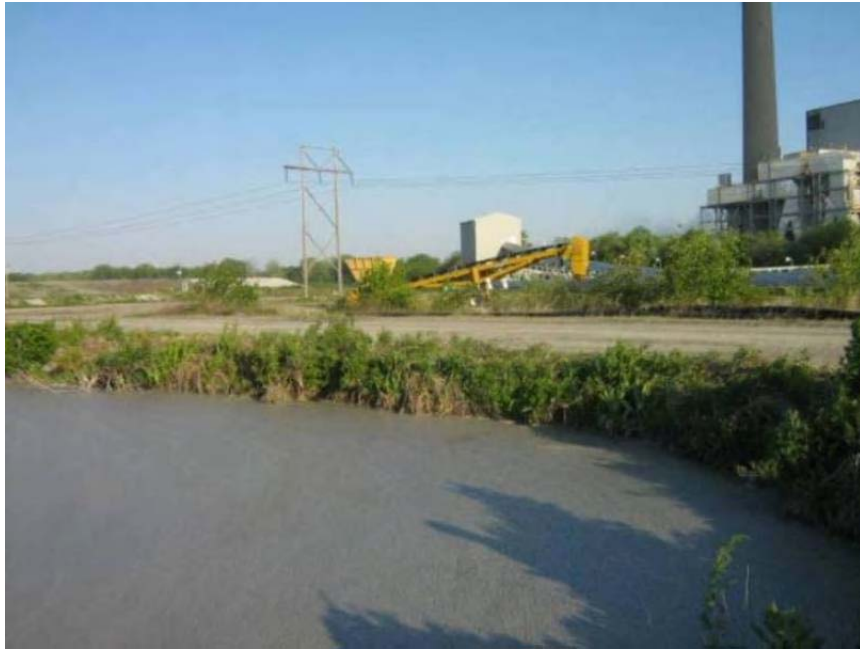
160. Ash Pond 4B - North Embankment Interior Slope, Looking North

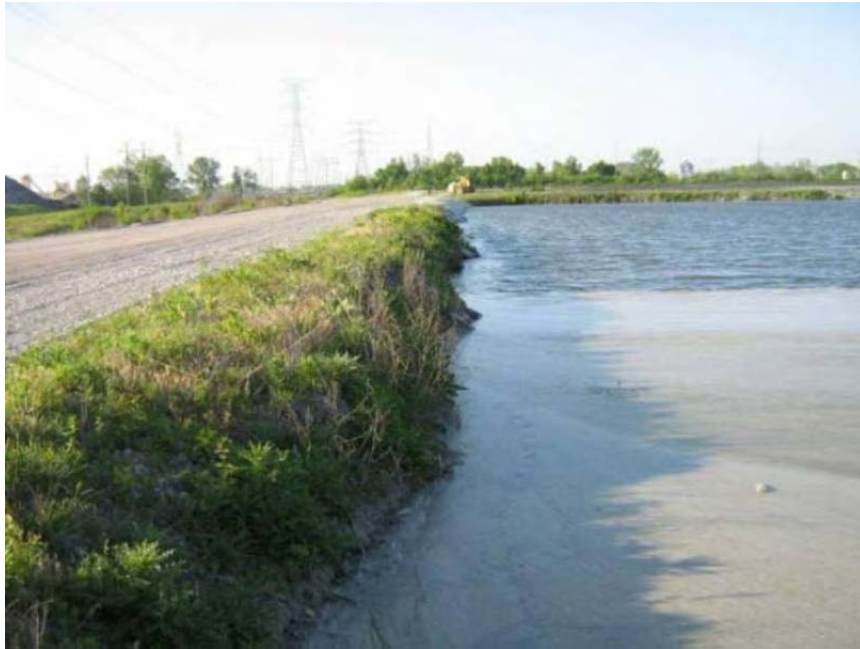
162. Ash Pond 4B - East Embankment Interior Slope, Looking South

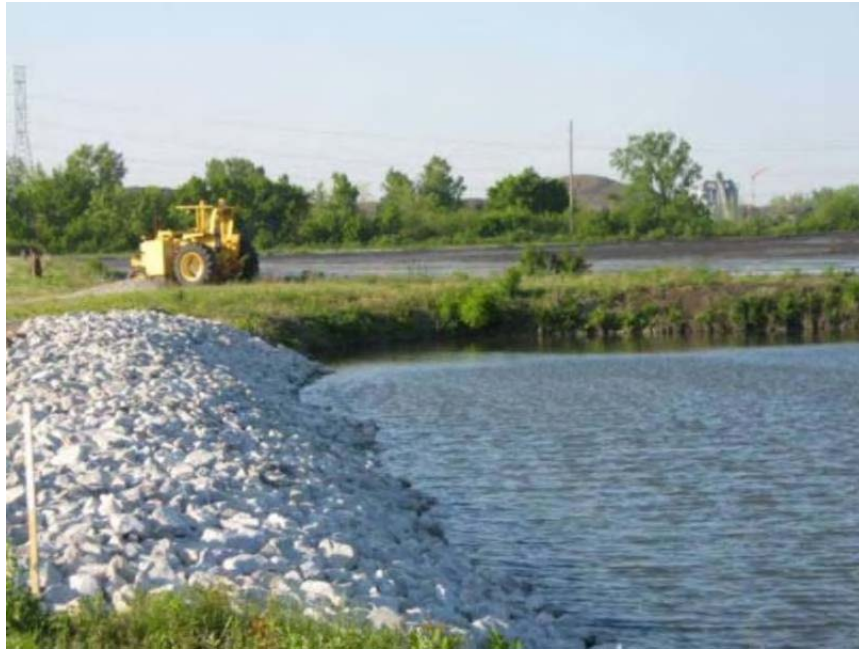
164. Ash Pond 4B - Riprap used to Stabilize Slope along East Embankment Interior Slope, Looking South
